Agenda Item: 15.6
Report to: Full Council
Date: Wednesday 17th February 2021
Subject: Roof at the community centre
Summary: To note obligations under lease.

The community centre has a history of leaks in the vicinity of the old parish council offices. This has been investigated by Liberty Property Trust whilst undertaking the community centre extension.

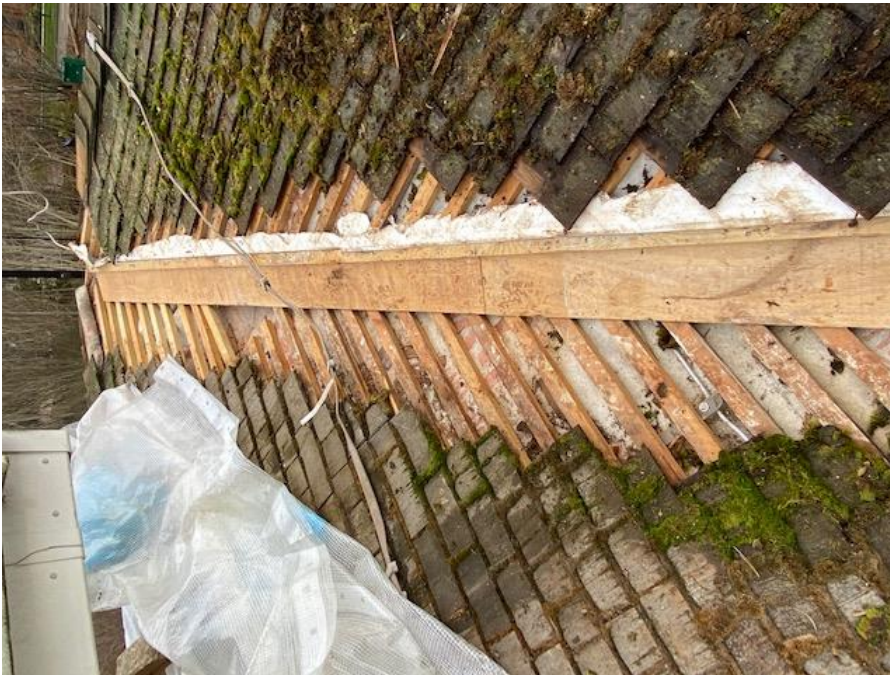
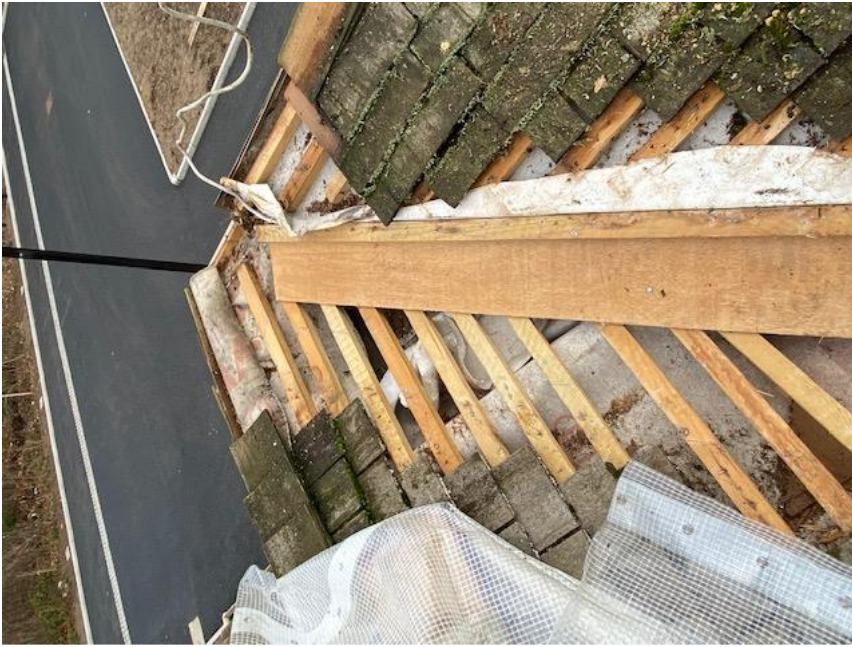
cutting into the valley (please see the copy of the letter we received from the clerk at the time dated 5 March 2010 stating that the extension to the offices was undertaken by Ballast Wiltshire). The old roof runs on its existing line and can be seen within the ceiling void in the office (please see the photos below).

The roofing felt should have been cut and dressed over a fillet fixed to the valley board running down both sides, see example plan attached (which is not shingle but the principal is the same). You can see on the photo below that there is only a valley board on one side, the battens carry through under the valley, and the felt has not been dressed up, so any water getting through the shingles at a higher level will run on the felt, right under the valley and continue on the old roof and into the office.

As the works to rectify the roof are considerably more extensive than previously thought, new quotes for three possible roofing options have been obtained for the works to re-roof the two pitched roofs that abut the valley over the existing office which are as follows:

We recommend Option 2.

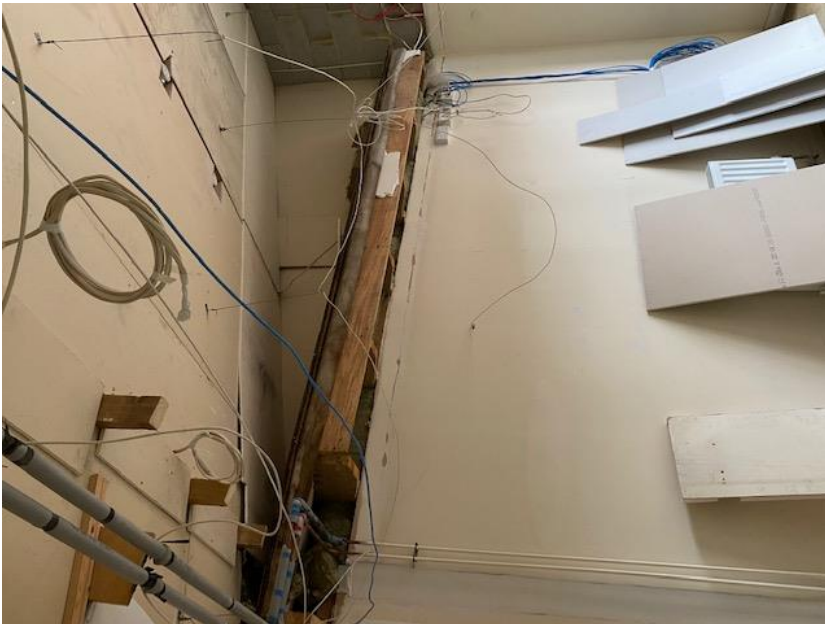
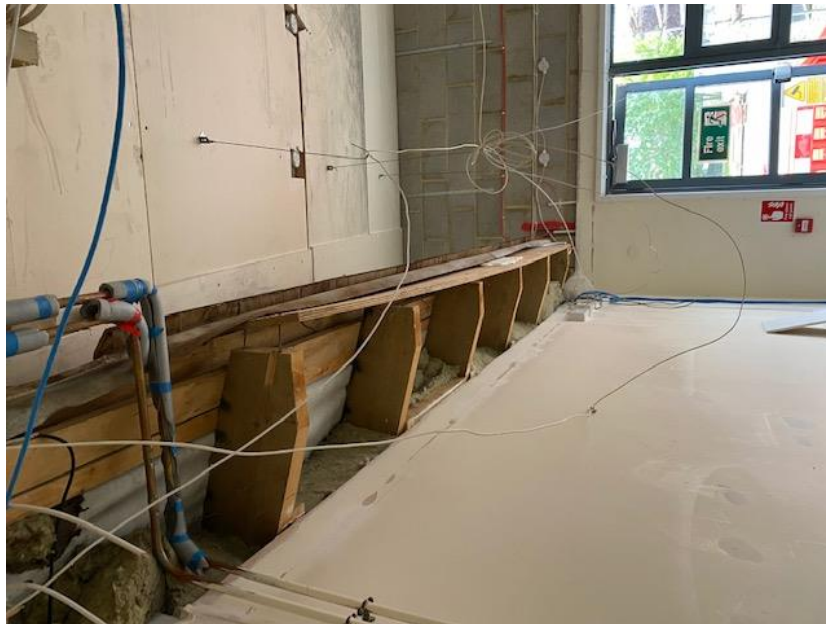
Evidence of old roof within the office ceiling void:

Water has been leaking into the office for a number of years and we understand has not been previously reported to the Landlord, these on-going leaks are therefore damaging the fabric of the building. In order to prevent further degradation the Landlord urgently requires that the roof is properly repaired which is a Service under the terms of the Lease.
